Supplemental Information & Instructions for Premium Ignition Rotors

151-805 or GRA2101HQ for 25D4 distributors (MGT, MGA, SPM 948-1275, TR2-4A)
151-865 or GRA2114HQ for 43B & 45D distributors (MGB 75-80, Midget/Spitfire 1500, XJ6 74-79)
872-785 or GRA102HQ for 25D6 distributors (Healey 100-6/3000, MGC, TR250, TR6 to 1974)

Instruction Sheet 151-805_GRA2101HQ_151-865_GRA2114_872-785_GRA102HQ June 2009

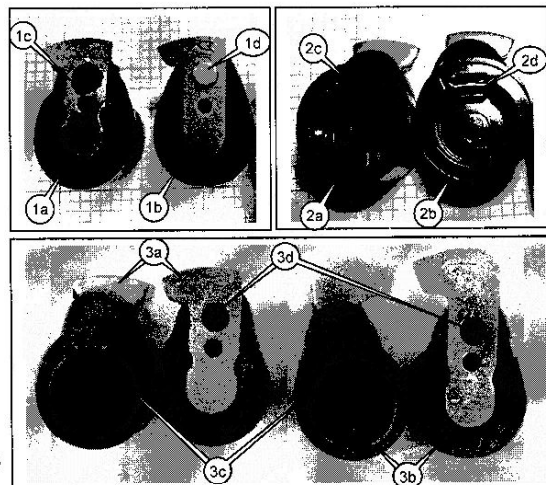
Rotor arms manufactured over the last decade are not exactly like the Lucas rotors (1a, 2a) made in the 50s and 60s. Specifically, these rotors (1b, 2b) have more carbon black in the plastic, which increases the conductivity of the material. On top of that, the original contact was molded into the body of the rotor (1c) while replacement rotors use a rivet. The lower end of the rivet is very close to the spring clip (2d) on the underside of the rotor. There is simply not a lot of insulating material separating the tip of the rivet and the spring clip. The high energy spark from the coil (30,000 volts or more) will always follow the path of least resistance. In some of these rotors, this path goes from the tip of the rivet, through the thin layer of more conductive plastic, through the spring clip on the underside of the rotor arm, finally grounding out on the shaft of the distributor. Initially when this happens one or more of the spark plugs will fail to fire.

This "miss" will sometimes heal itself if the engine is given a chance to cool off, but it always comes back, and in the end, the rotor will simply short out completely, which could leave you stuck on the side of the road.

The Premium Ignition Rotors we offer for Lucas distributors are based on the rotors made by Lucas in the 1960s for 4 and 6 cylinder applications. These rotors (3a, 3b) are manufactured from a highly non-conductive resin ideally suited for modern high-energy ignition systems. The brass contact is molded to the body when the body is made, eliminating the rivet. There is no chance for the contact to ground through to the distributor shaft. The socket is precisely sized, which, combined with the spring clip (3c), ensures that the rotor fits tightly on the distributor shaft. All of these factors combined make these Premium Rotors far superior to the other rotors available at this time, and this is reflected in the fact that they are warranted against defects in material and/or workmanship for three years.

Yes. If the ignition problem you are having is caused by the internal short in the rotor, these new rotors will absolutely cure the problem. Feedback from staff at Moss (both in the US and in the UK) is all favorable. A number of shops have reported success curing a troublesome miss by replacing what appeared to be a perfectly good rotor with one of these Premium Rotors.

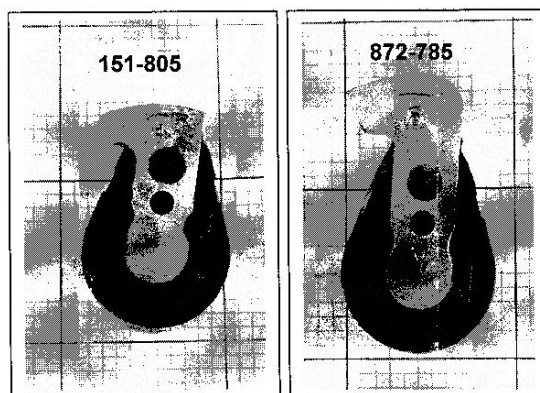
After years of use, the top of the distributor shaft may have been repeatedly cleaned with wire brushes or emery cloth. Our supplier, who sees hundreds of used distributors every year, reports that it is quite common to see distributor shafts with a smaller outside diameter. As a result, a new rotor at the upper end of the original tolerance range may not fit snugly on the shaft. These Premium Rotors have a tighter tolerance on the inside diameter with less variation between rotors, both of which help ensure a snug fit on a used distributor shaft.
